**CLINTON COUNTY COURTHOUSE  
HISTORIC STRUCTURES REPORT**

**JULY 27, 1989**

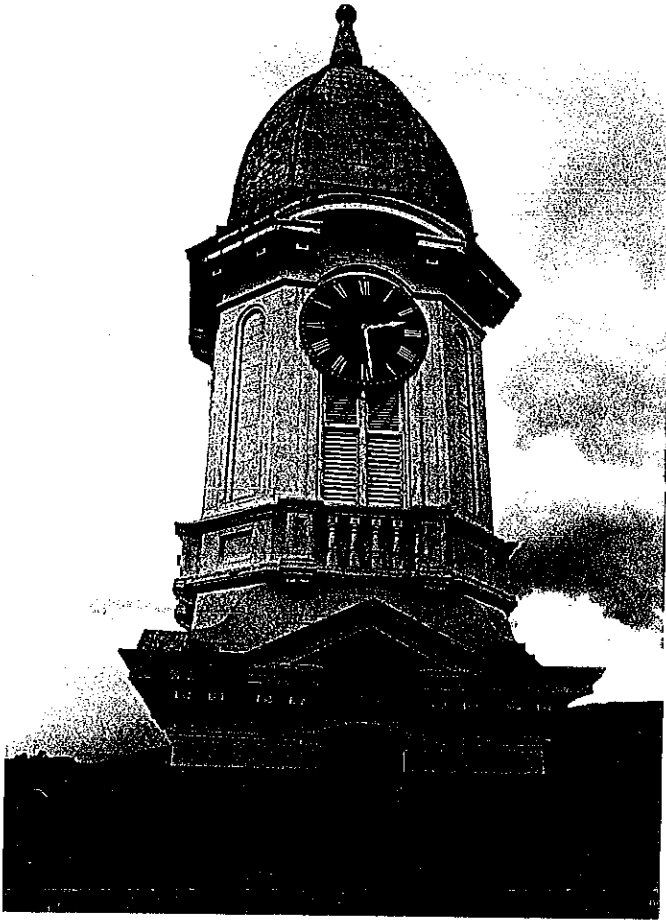
The twin towers on the north facade of the building are of wood frame construction with metal siding and roofing and applied wood trim. The roofing and siding are in fair condition, requiring maintenance work such as repairing joints and repainting. Wood cornice work is in

fair condition with rotten areas limited to isolated corner and joint conditions. Wood ballusters, windows, moldings, and dentils are generally in good condition but in need of repainting.

(5) View of the western face of the clock tower.

All rotten and deteriorated woodwork shall be replaced. This shall include ballusters, moldings, dentils, soffit, siding and louvers. The clock faces on the east tower shall be replaced. All woodwork shall be scraped, primed, and painted. Metal siding shall be scraped, primed, and painted.

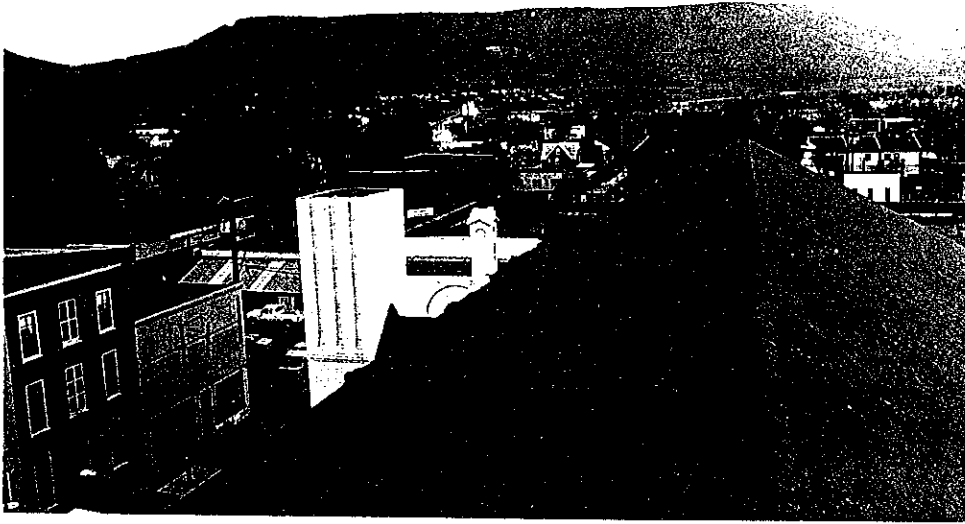
Two prominent masonry chimneys exist, one on the east and the west elevations. The western chimney is in fair condition - some repointing work is required. The eastern chimney has had the top four feet removed and that which is left standing above the roof line is in poor condition with full depth cracks and loose brick at the top-most courses.

(11) View of asphalt shingle roof and east chimney.

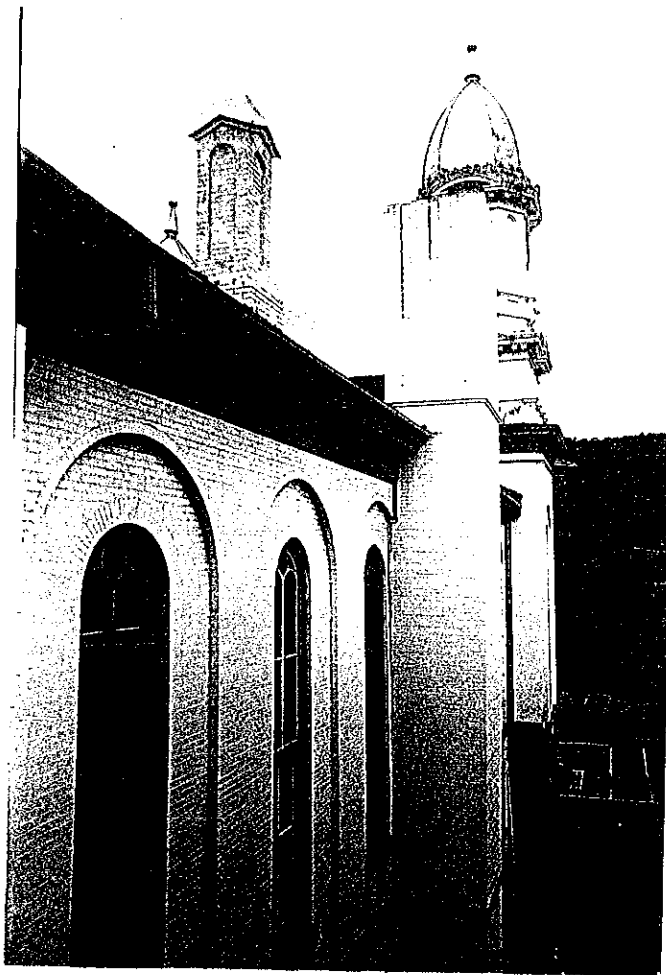
(12) View of chimneys at east elevation.

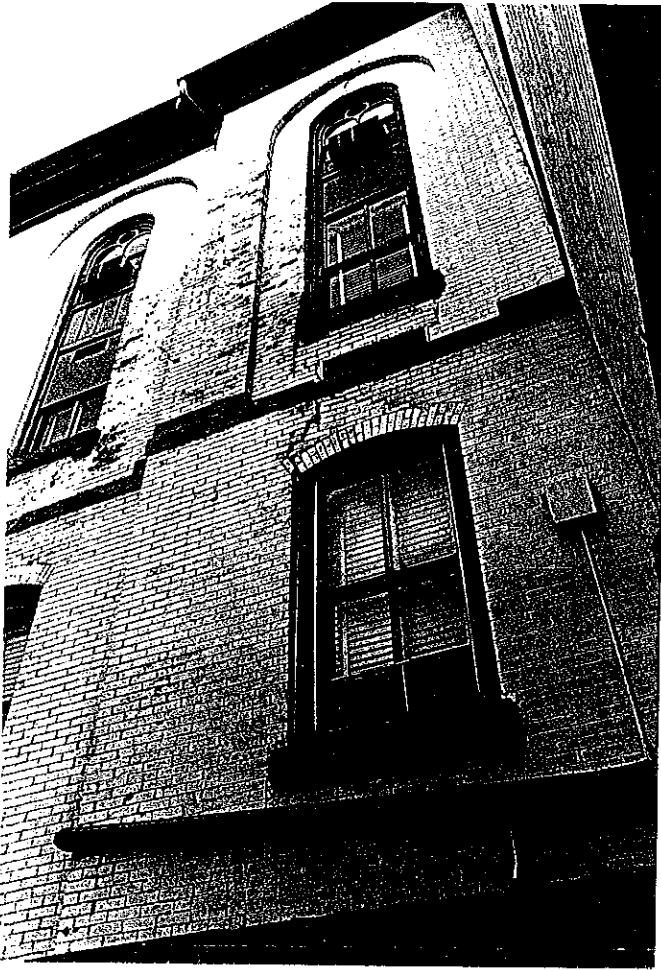
This occurrence on the west wall resulted in the brick veneer delaminating and separation of approximately 2" at the midpoint of the tall vertical window openings. The architects recommended immediate action on this section of the wall due to the fact that additional freeze/thaw cycles over the winter could accelerate the delamination and cause the face veneer to collapse. Work on this section of wall began in December, 1988, and is being completed in January, 1989.

(13) Detail view of masonry deterioration at the west facade.

Face brick on exterior walls shall be cleaned of any loose paint. Individual brick that have deteriorated or spalled shall be replaced. Areas of severe weathering shall have joints raked and shall be repointed with mortar to match existing. All exterior brickwork shall be repainted.

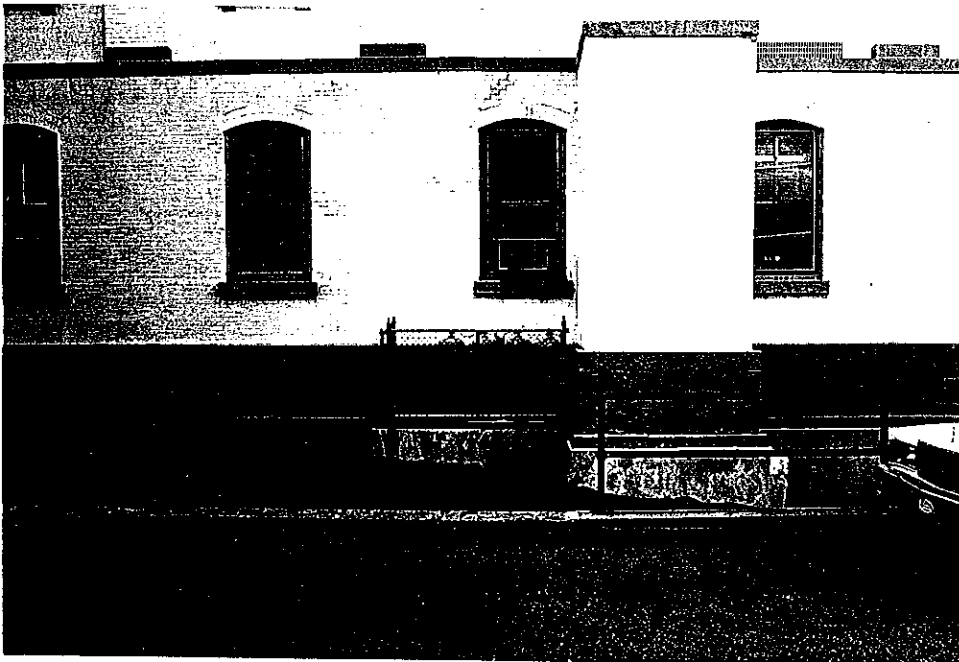
(14) Detail view of west chimney base.

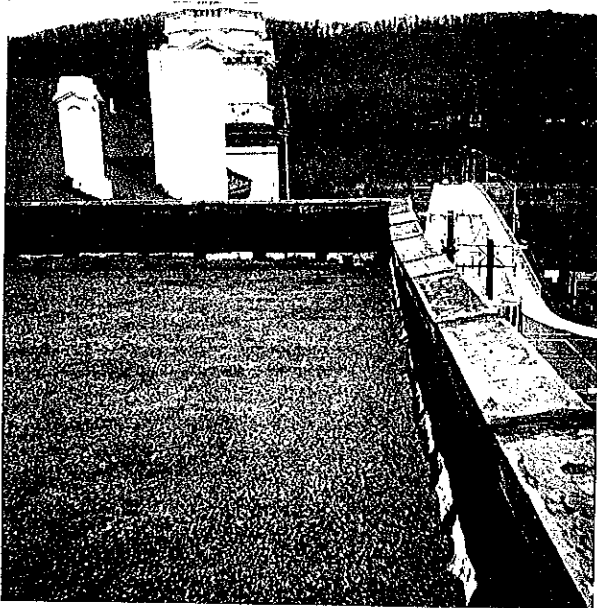
The roof on the southern portion of the building is a flat built-up roof in fair condition. The masonry parapet walls which extend approximately 24" above the roof surface are in very poor condition. Two of the three parapet walls are leaning inward toward the roof and, over time, it is possible they could collapse. Limestone coping cap on these parapet walls is in good condition.

(16) View of the parapet wall at the 1936 addition.
