**STROSSER ARCHITECTURE
& CONSERVATION, INC.**

**PRESERVATION PLAN
CLINTON COUNTY COURTHOUSE**

FEBRUARY 2018

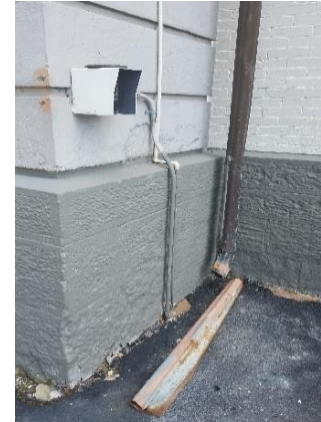
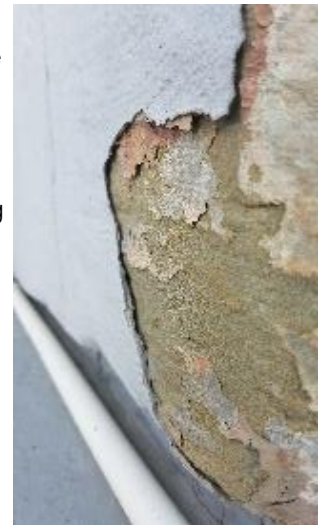
Historic cut stone (Farrandsville Stone) foundation walls exposed above grade have been painted, starting in the 1950s. Modern paints (likely latex) are trapping moisture within the stone and leading to deterioration of both the stone and mortar joints. The stone does not hold the painted coating very well, leading to premature peeling/flaking. This is already happening to the recent painted areas. There is also some spalling of the surface of the stone. This is extreme at all stair locations where salt/ice melt is used and moisture is held against the stone.

1	Remove spalling stone at deteriorated areas and consolidate remaining stone. Test areas Must be complete to determine the appropriate product (examples being Edison Coatings, Prosoco H100 or Protectosil). Patch with appropriate stone patching system (Edison Coatings). Prepare and re-paint areas with appropriate coating.	\$ 25,000.00
3	If paint can be removed, remove paint at all stone areas, repair and re-point as necessary	\$ 45,000.00

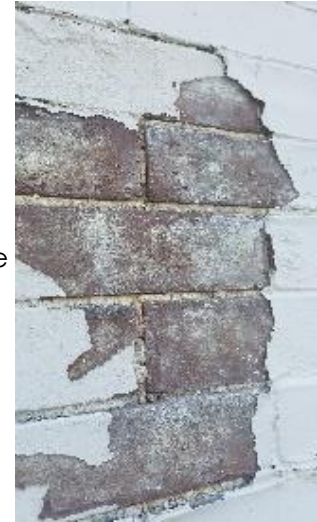
Historic hard red brick has been painted, starting in the 1950s. Original specifications called for 'the best Philadelphia press brick' on the front and 'the best Lock Haven press brick' on the sides and rear. Overall seems to be in good condition with some localized areas of deterioration. These areas are noted on the elevations and correspond to gutter & downspout issues. The painted coating is likely a modern latex on the most outer layers which is holding moisture within the walls, accelerating the deterioration. Overall, the mortar joints are tight and generally intact.

1	Once gutters are repaired, remove loose paint, prepare and re-paint areas of damage. Use test areas to determine if paint can be removed without further damage to brick	\$ 25,000.00
3	If paint can be removed, remove paint at all brick areas, repair and re-point as necessary	\$ 150,000.00

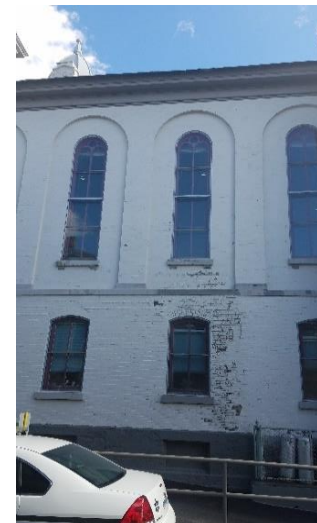
The gutters appear to be copper, 4" half-round leading to 4" copper downspouts. The configuration is indicated on the elevations. There are two per side, draining the main roof. This seems to potentially be a lot of water for such a small gutter/downspout system. There are two specific gutter concerns; a low spot on the East side which allows water to sheet down the wall. Similarly, an open joint in the gutter on the West side is allowing sheet flow and subsequent deterioration.

1	Repair open joints and low spot as indicated in assessment	\$ 8,000.00
2	Replace with larger gutters	\$ 20,000.00

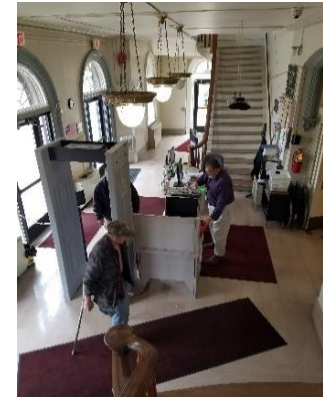
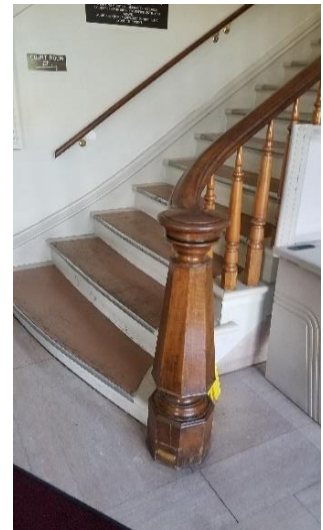
Wood painted with a linoleum sheet protector with an aluminum nosing. The linoleum is quite worn but otherwise is an appropriate treatment to protect the wood treads. Likely the riser would have been painted and the treads protected with a clear coating.

Railings seem original and in good condition. A newer handrail along the walls basically matches wood stain on original railings. Painted wood base at landings and outside walls.

2	Remove linoleum, restore wood treads and paint/coat all surfaces.	\$	15,000.00
---	---	----	-----------

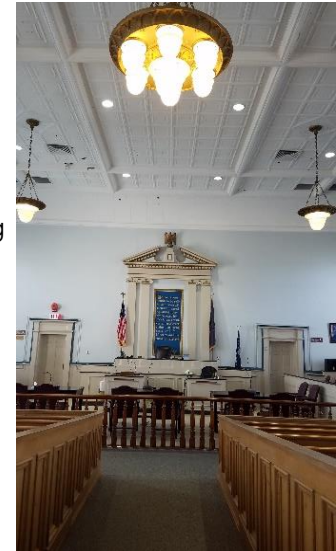
Five decorative ceiling lights seem appropriate from a light level and design standpoint. Addition recessed downlights have been added to help increase lighting levels. The decorative fixtures need to be assessed in detail for safety and detailed condition. Some of the globes are have been replaced and are 'off' color.

A	WALLS		
	3	Ideally re-wire to eliminate wire-mould, conceal modern equipment to greatest extent practical	\$ 5,000.00
B	CEILINGS		
	1	Strip ceiling of all coatings down to sound metal. Confirm moisture/cause of peeling. Re-paint with specially formulated coating for metal surface.	\$ 20,000.00
C	FLOORING		
		No work	
D	DOORS - INTERIOR		
		No work	
E	TRIM ELEMENTS		
		No work	
F	FIXTURES		
		Research, assess and Refurbish/Replicate Historic Light Fixtures	\$ 15,000.00
