Bluebird Lane, PA Game Commission

BEFORE AND AFTER

Final Inspection 6/16/2020

Stream Impacted – Tributary to Fishing Creek  
– HQ & Wild Trout Fishery

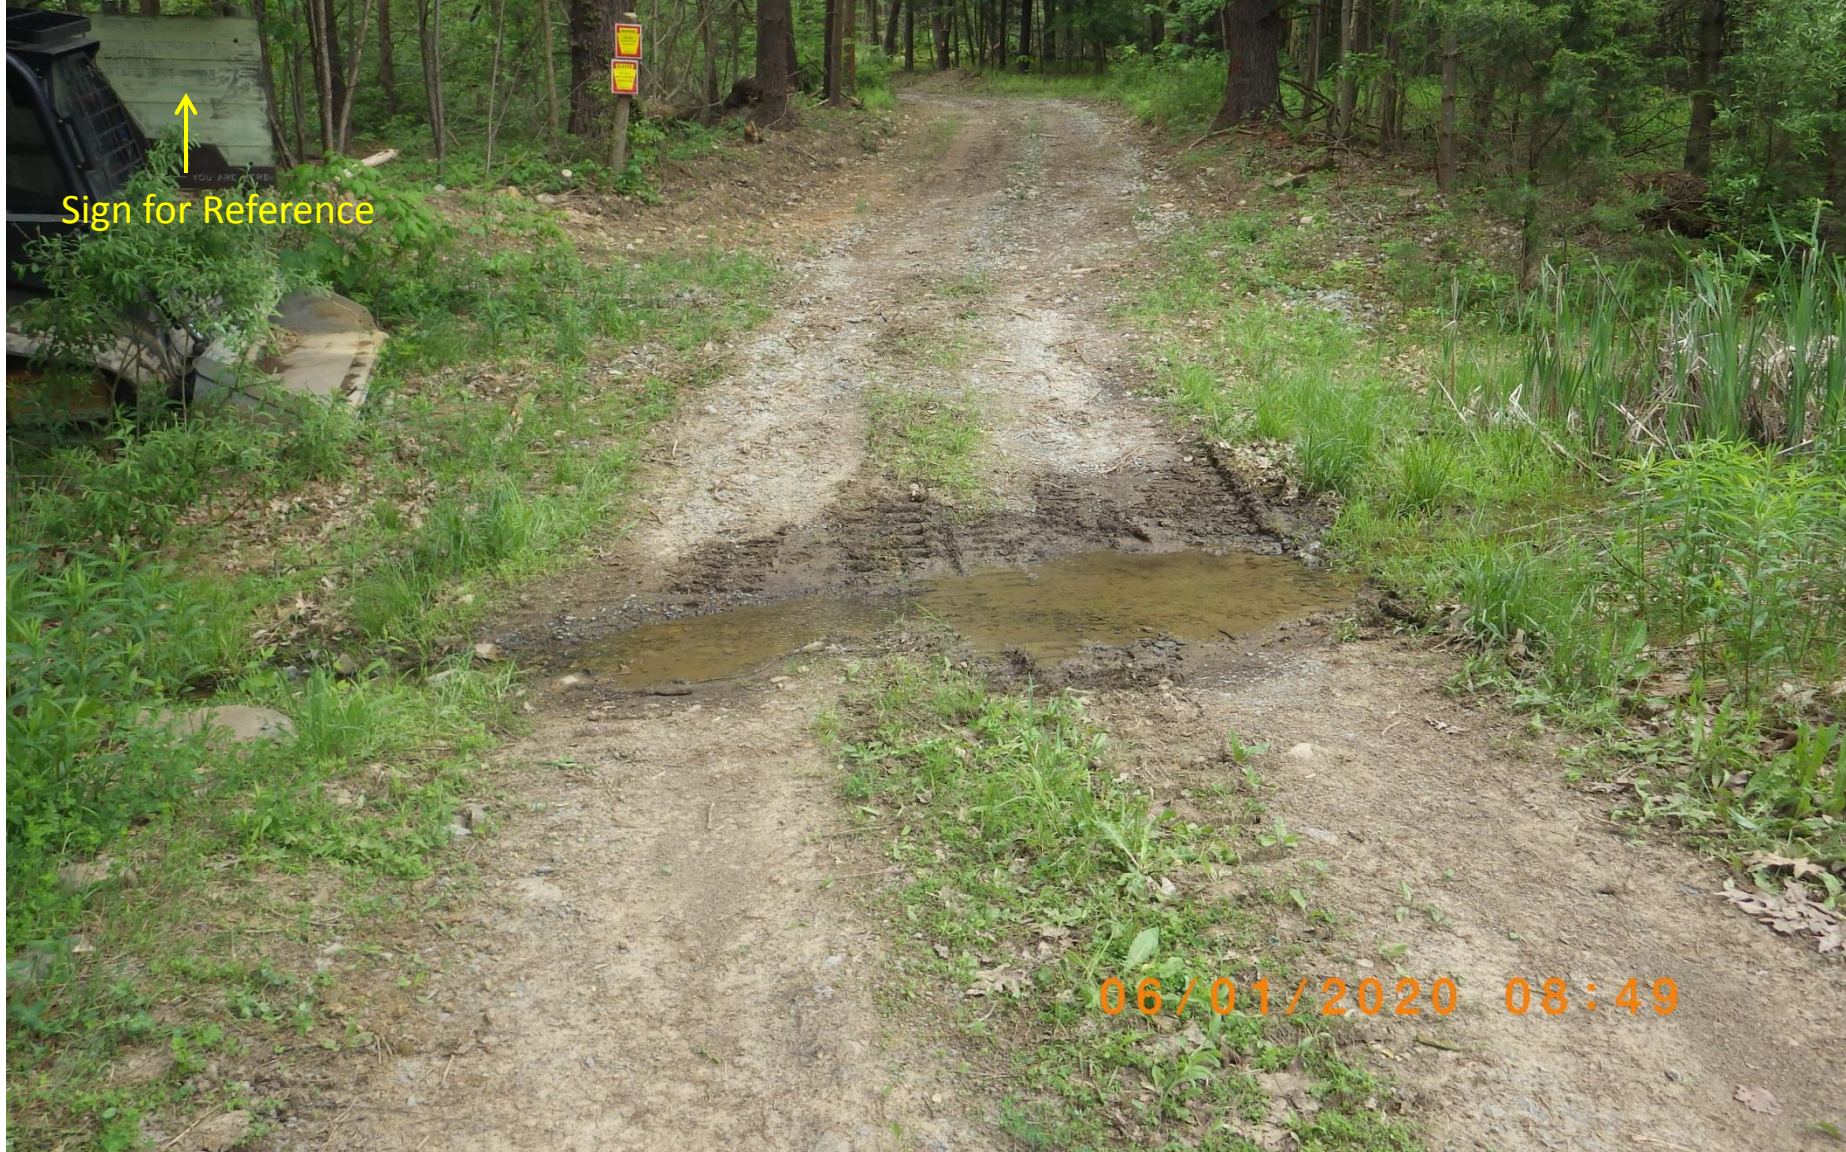
06/01/2020 08:49

Bluebird Lane BEFORE: This is an example of where road sediment was able to wash into a field diversion that outlets directly to the stream or sinkhole. This diversion was similar to several others on the property in that it flows overtop of the road. This diversion also drained several springs and was a constant source of water reaching the road and a constant source of erosion and surface problems.
